SUBJECT: June 2015 Inspection Report for the former Cornell Dubilier Electronics (CDE) Superfund

Site, South Plainfield, New Jersey

DATE: June 30, 2015

Preliminary Surface Sand Filter Drain Time Analysis

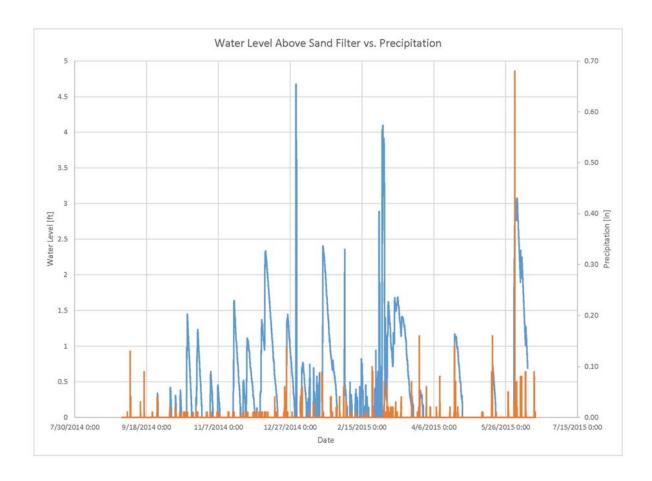
Figure 1. Timeseries of water level above the sand filter versus precipitation.

The full timeseries of water level above the sand filter versus precipitation measured at the rain gauge in Middlesex, NJ is presented in Figure 1. Individual precipitation events and their associated drainage times are presented below.

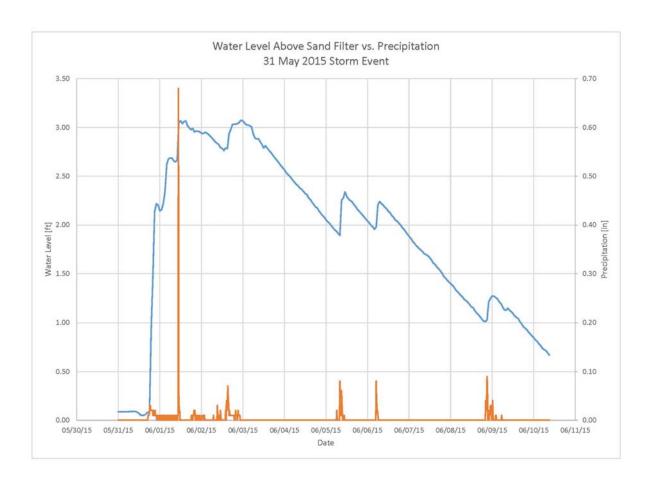
Figure 2. Sand filter drainage time for 31 May 2015 Storm Event.

During the period 31 May 2015 – 2 June 2015, the site received the largest amount of precipitation recorded since the pressure transducer was installed in the detention basin in September 2014. Figure 2 shows the water level above the sand filter along with precipitation data from the rain gauge in Middlesex, NJ. Twenty-four hour precipitation totals are listed below in Table 1.

During this period, the highest rain rate recorded was 0.78 inches in a two hour period on 1 June. This is below the design storm event of 1.25 inches in a two hour period.

Using data from the 31 May -2 June precipitation event (Figures 1 and 2) the peak water level above the sand bed for this precipitation event was 3.07 feet at 2300 hours on 2 June 2015. Using the minimum sand bed surface area (A_s) from Equation 9.9-1, and multiplying by 3.07 feet this equates to approximately 29,656 ft³ of water. Solving for T_D yields a sand bed drain time of 9.8 hours.

As shown in Figure 2, the sand bed had only drained down to a water level of 1.89 feet (net change of 1.18 feet) before the next precipitation event started at 0615 on 5 June 2015, with an average drainage rate of 0.5 feet per day.

This data suggests that the current permeability of the sand bed is significantly less than the design permeability of 4 ft/day.

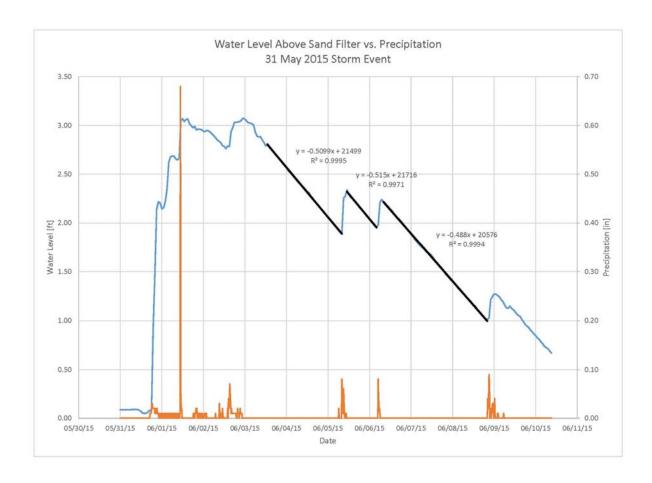
Figure 3. Sand filter drainage time for 31 May 2015 Storm Event with linear regressions during drainage.

Figure 3 includes three linear regressions fitted to the water level above the sand filter between precipitation events while the sand filter is draining. These regressions show that the sand filter has an average drain rate of approximately 0.5 ft/day.

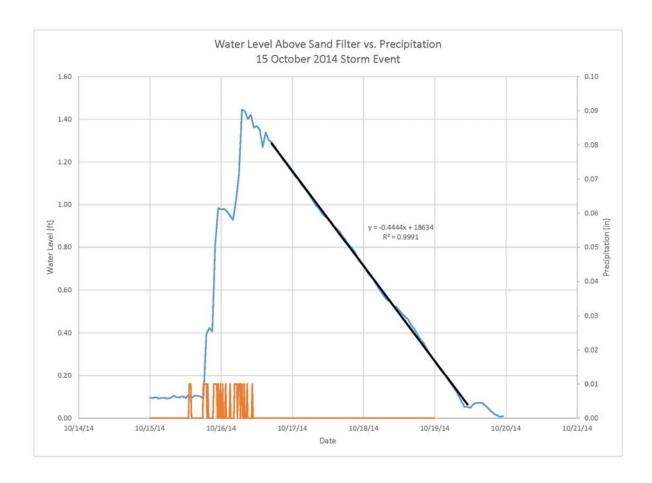
Figure 3. Sand filter drainage time for 15 October 2014 Storm Event with linear regression during drainage.

Figure 3 includes a linear regressions fitted to the water level above the sand filter after precipitation on 15-16 October while the sand filter is draining. This regression shows that the sand filter has an average drain rate of slightly less than 0.5 ft/day.
